Quality Audit Response Document Proposed Residential Development Drumlark, Co. Cavan

Client: Drumlark Investments Ltd Job No. D111 February 2024 DUBLIN LONDON LIMERICK

PROPOSED HOUSING DEVELOPMENT AT DRUMLARK, CO. CAVAN

Stage 1 Quality Audit

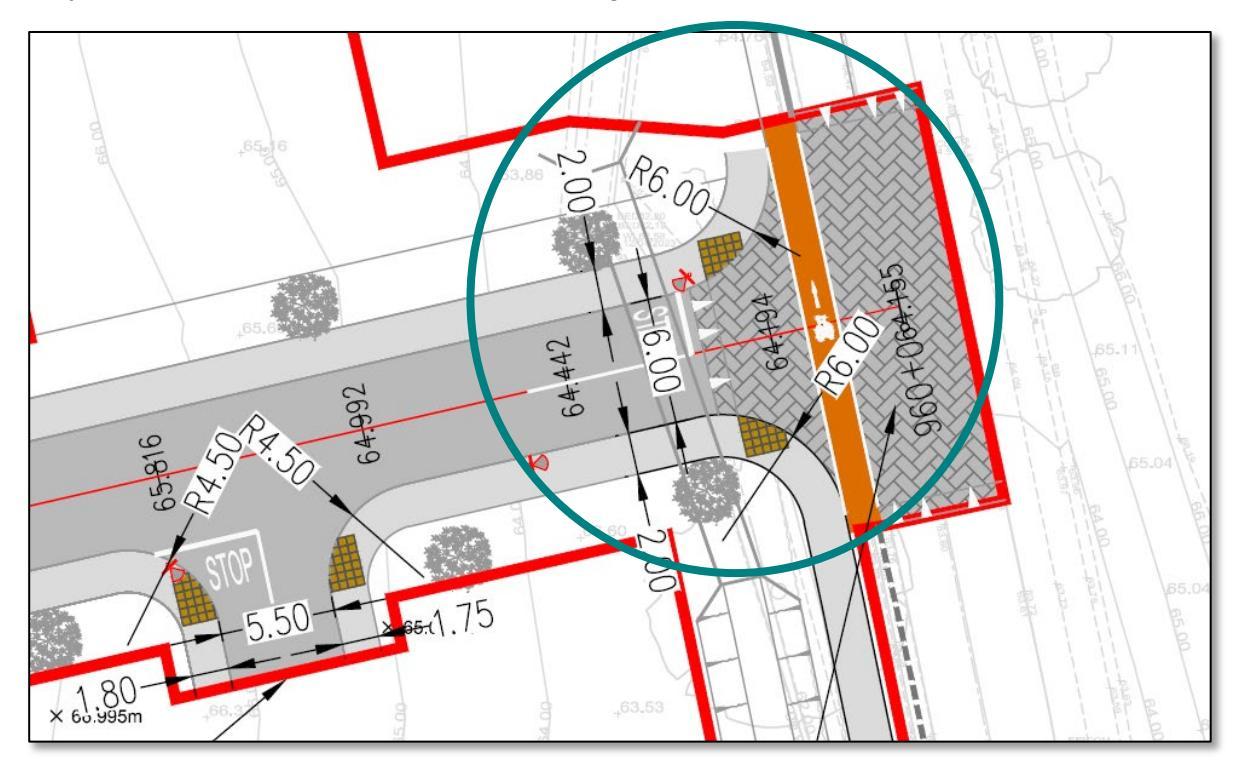
5.1 <u>Issue</u>

Visibility for a driver exiting the proposed development may be restricted by the existing roadside hedges either side of the access. Inadequate visibility may contribute to a turning collision at the access. There is a particular risk in relation to visibility to the right: due to the curvature of the L-1532 south of the access a short section of road (and any vehicle thereon) may be concealed from the view of the exiting driver.

Unobstructed sightlines of 59m in both directions of L1532 shall be achieved as measured from a set-back of 2.4m in accordance with DMURS. Sightline envelope shall remain free of any obstructions. Please refer to CS Consulting drawing no **D111-CSC-XX-XX-DR-C-0025** for further details

Ensure that adequate visibility splays are provided for drivers exiting the development.

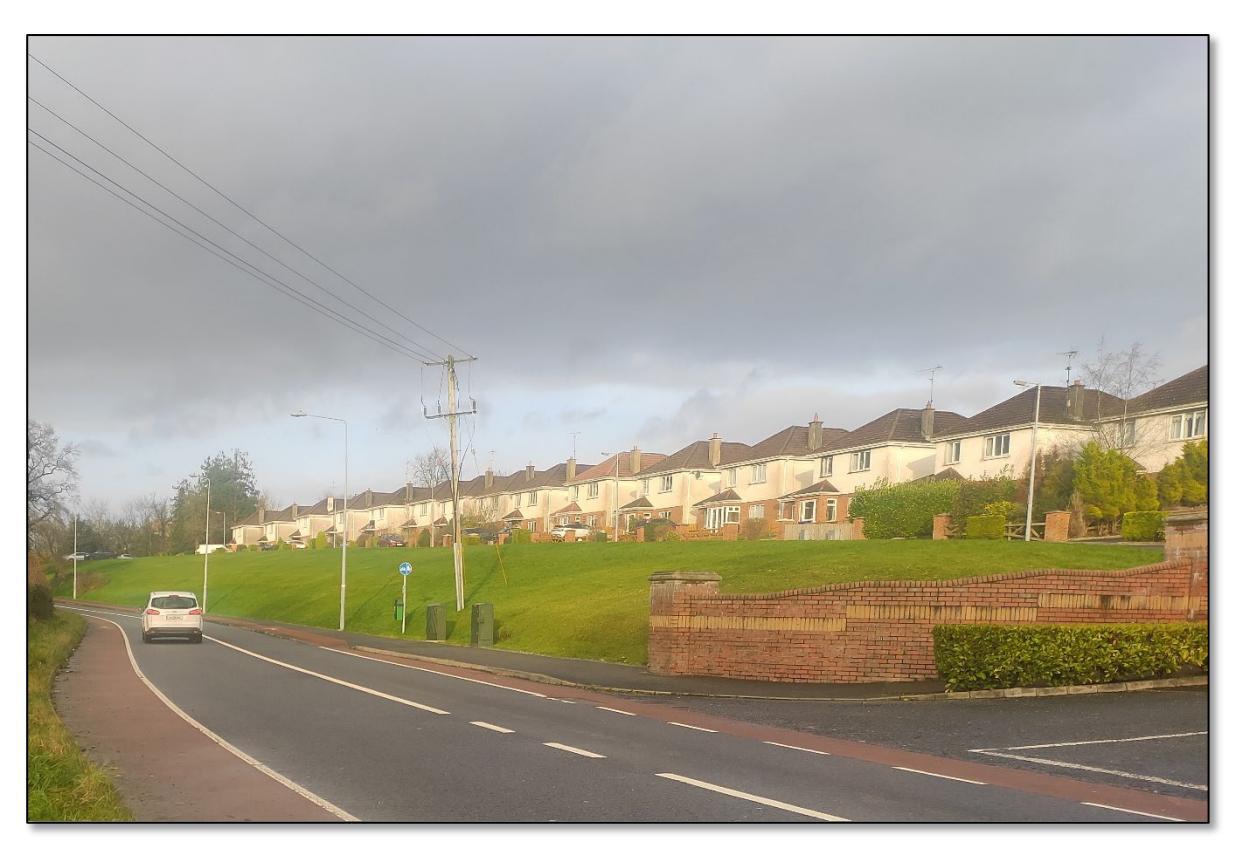
5.2 <u>Issue</u>

The L-1532 is lit but there is a gap in the lighting to the immediate north of the access to the Gallops (there is an overhead ESB service crossing the road and a risk of arcing would arise if a lighting column were located adjacent to the wires). This is also the location at which the pedestrian

crossing is proposed. The risk of pedestrian collisions would increase if the crossing were inadequately lit. In addition, street lighting is not shown to be provided within the proposed development. Road safety would be enhanced with the provision of street lighting.

The L-1532 is lit but there is a gap in the lighting to the immediate north of the access to the Gallops (there is an overhead ESB service crossing the road and a risk of arcing would arise if a lighting column were located adjacent to the wires). This is also the location at which the pedestrian crossing is proposed. The risk of pedestrian collisions would increase if the crossing were inadequately lit. In addition, street lighting is not shown to be provided within the proposed development. Road safety would be enhanced with the provision of street lighting.

The proposed zebra crossing shall be adequately lit. Street lighting shall be provided within the proposed development.

- Ensure that the Zebra crossing (and all other pedestrian crossings) is adequately lit.
- Provide adequate street lighting within the proposed development.

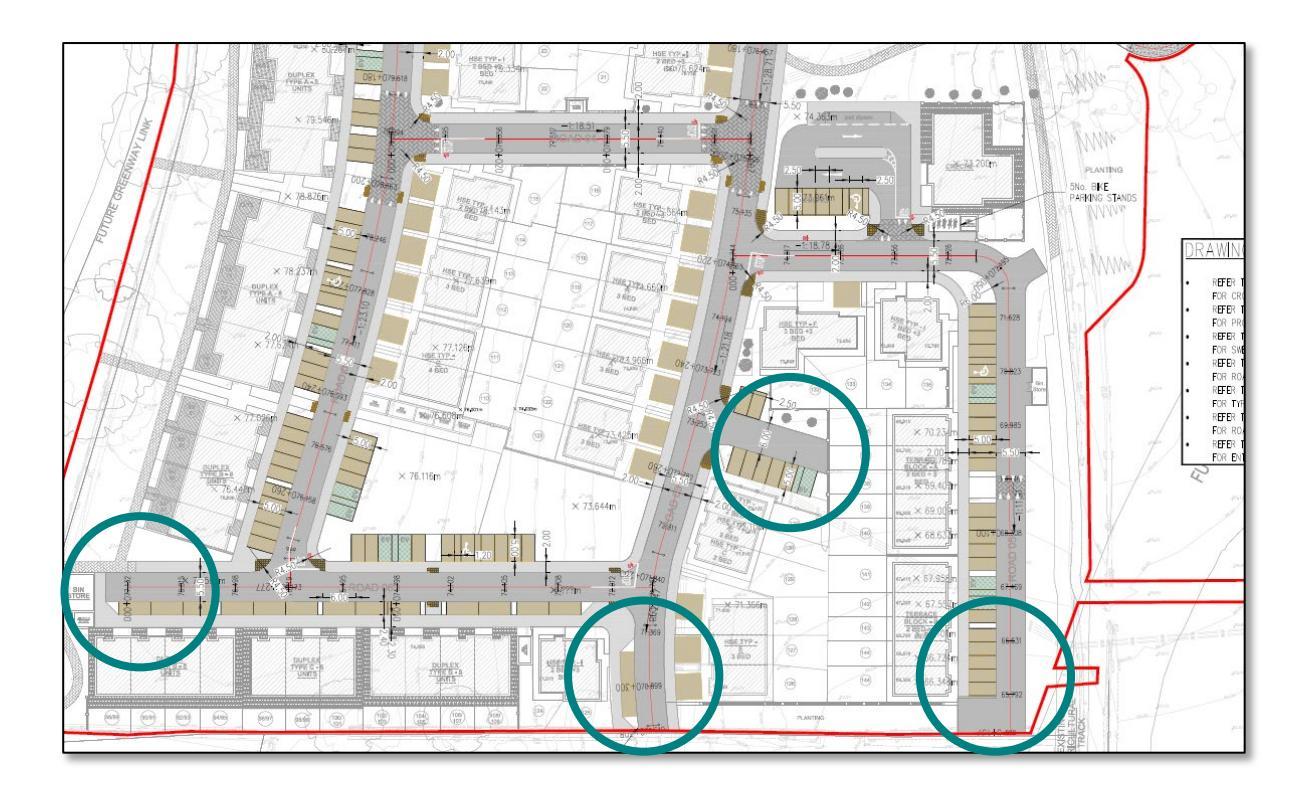
5.4 <u>Issue</u>

Some turning heads at the ends of cul-de-sacs appear too small to provide sufficient space in which a refuse vehicle could turn. If large vehicles need to reverse, they could pose a hazard to vulnerable road users. It is acknowledged that, in the case of short cul-de-sacs, the refuse vehicle would turn at the adjacent junction.

Turning heads shall be large enough to be used with ease by refuse vehicles. Please refer to CS Consulting drawing no. **D111-CSC-XX-XX-DR-C-0012** for details.

Ensure that turning heads are large enough to be used with ease by refuse vehicles.

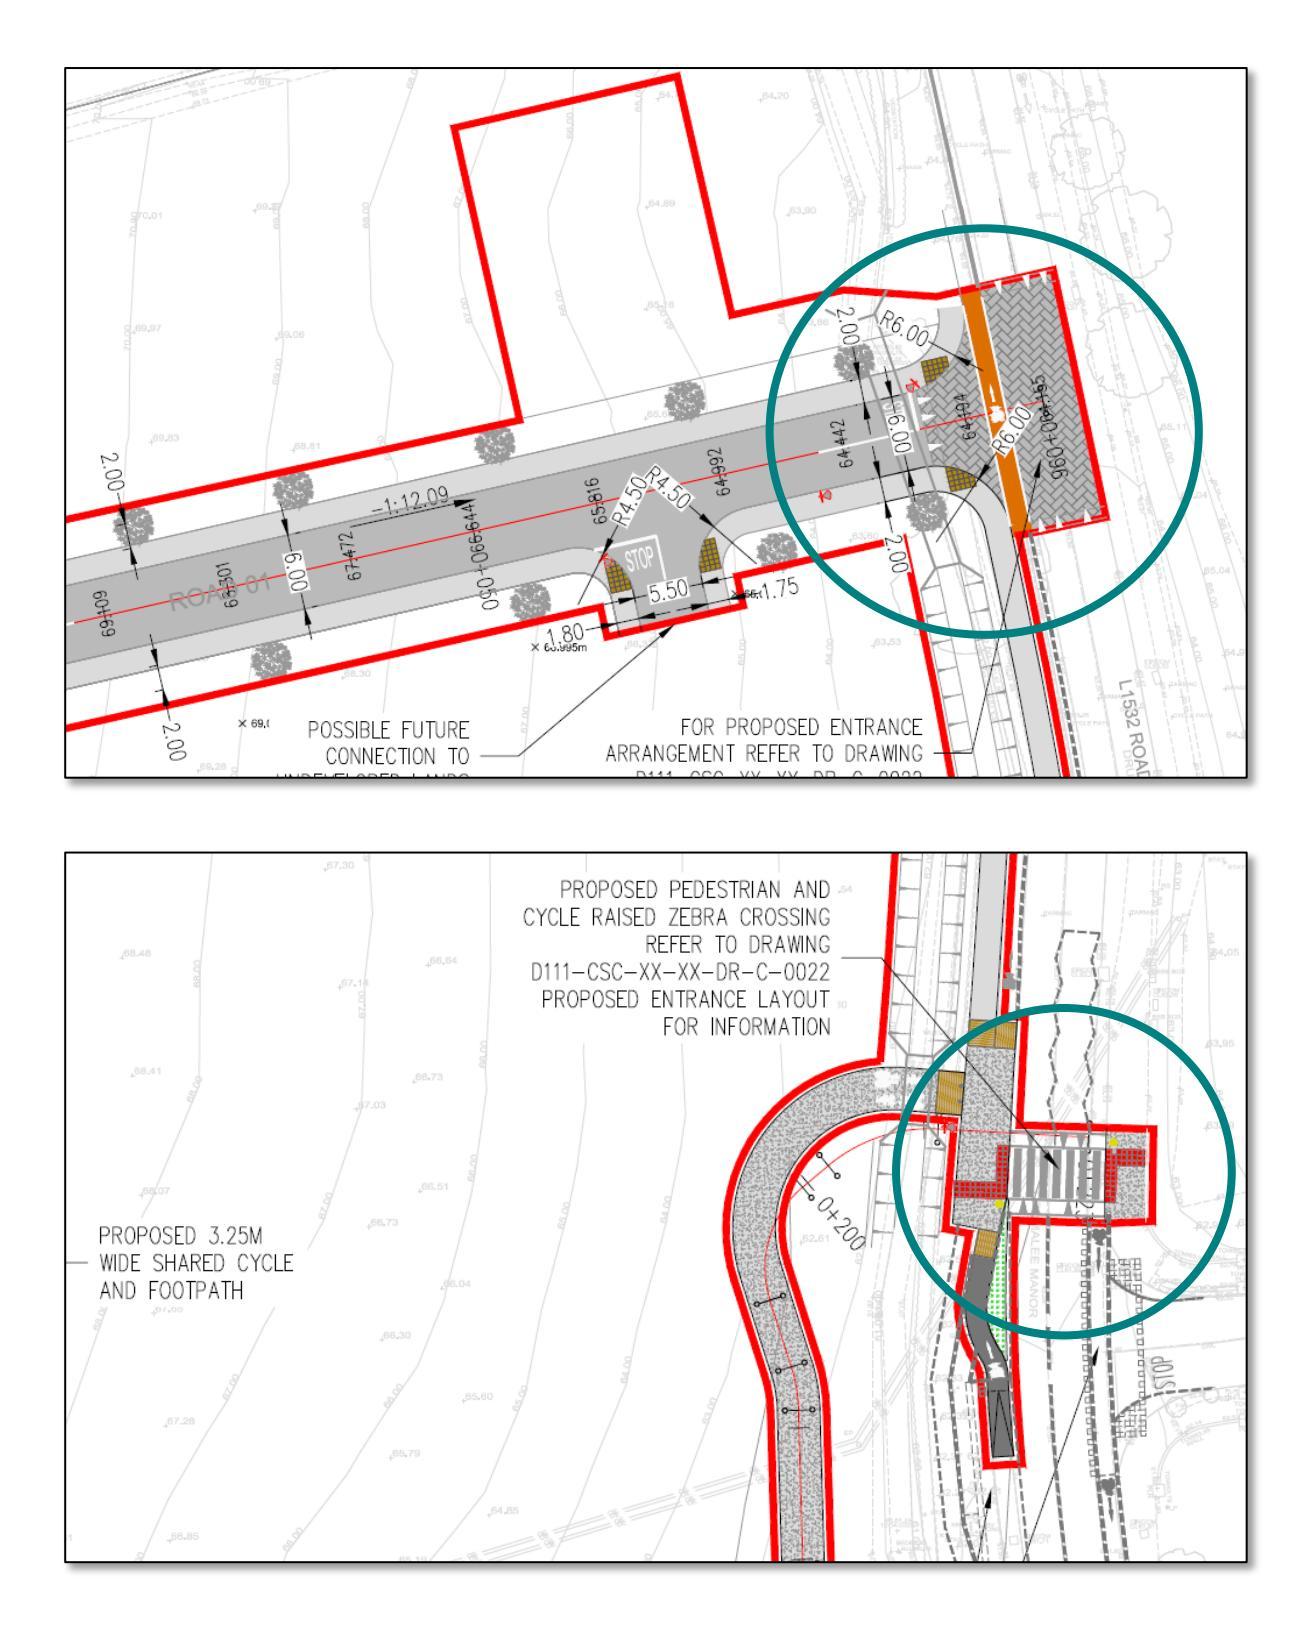
5.6 **Issue**

A raised table is shown to be provided on the L-1532 at the vehicular access to the site, and the proposed Zebra crossing to the south of that location is also shown to be raised. Speeding drivers may lose control if they strike ramps unexpectedly.

Road Humps warning signs shall be provided in advance of the ramps. Please refer to CS Consulting Drawing no. **D111-CSC-XX-XX-DR-C-0025** for further details.

Provide Road Hump warning signs in advance of the ramps.

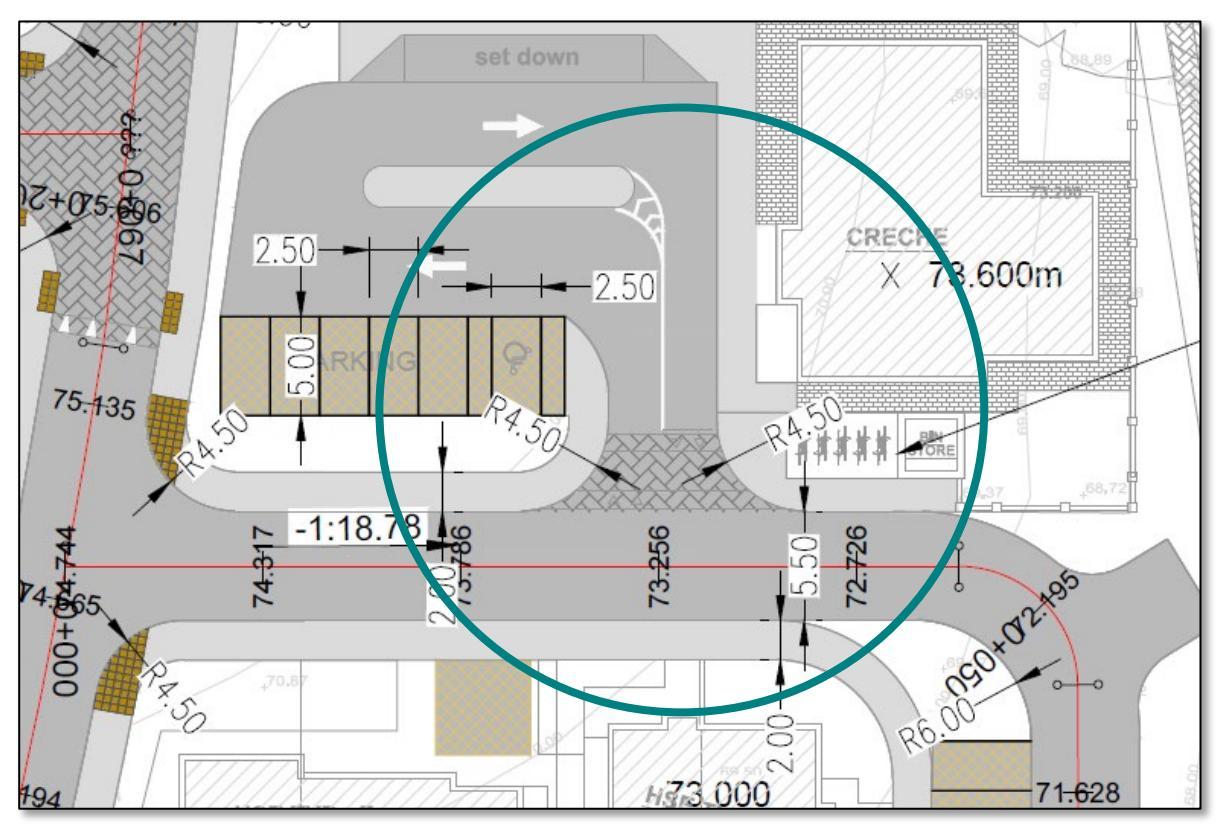
6.1 <u>Issue</u>

There are no crossing facilities provided to cater for pedestrians accessing the creche from the proposed footpath provided along Road 5.

Uncontrolled pedestrian crossing has now been provided on Road 5.

Provide a simple crossing of Road 5 at an appropriate location.

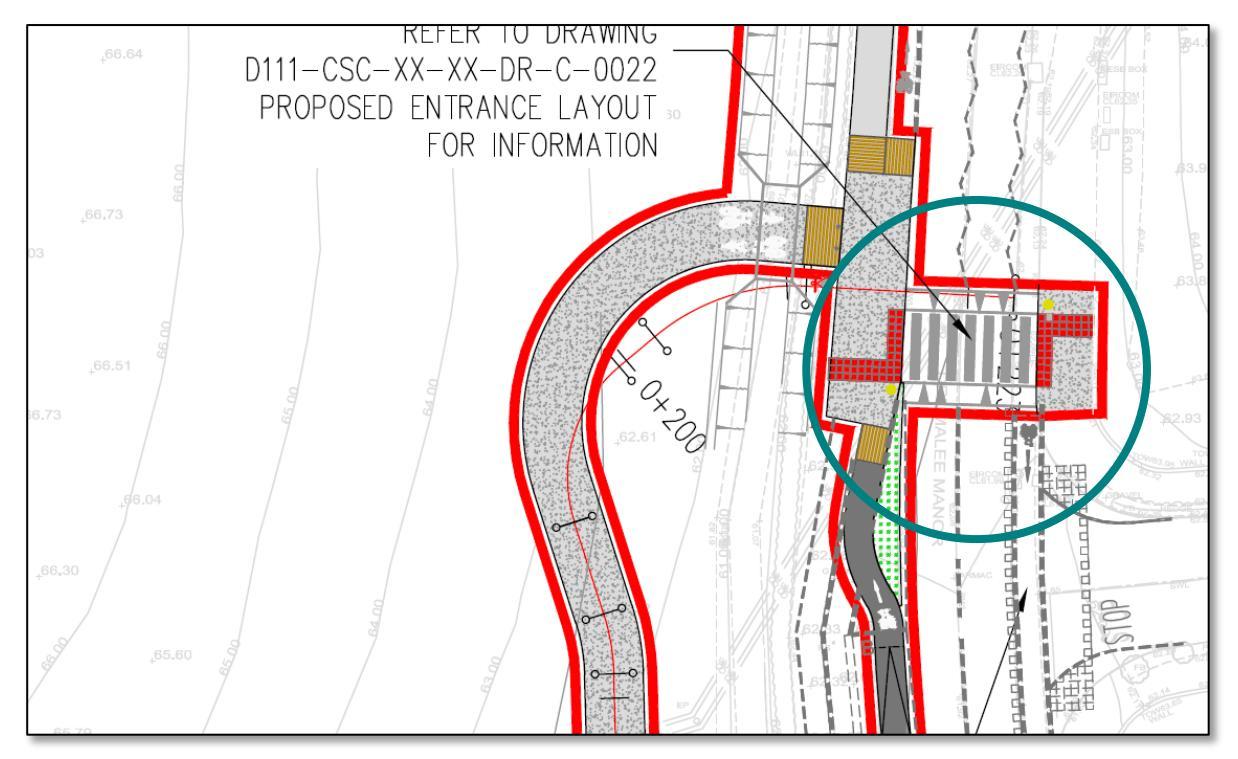
6. 2 <u>Issue</u>

Tactile paving is not shown to be provided on the east side of the proposed Zebra crossing beside the access to The Moorings to enable a visually impaired user to differentiate between the footway and the cycleway.

Corduroy tactile paving shall be provided at the interfaces between the shared surface area and the footway and cycleway. Refer to drawing **D111-CSC-XX-XX-DR-C-0025** for further details.

Provide Corduroy tactile paving at the interfaces between the shared area and the footway and cycleway.

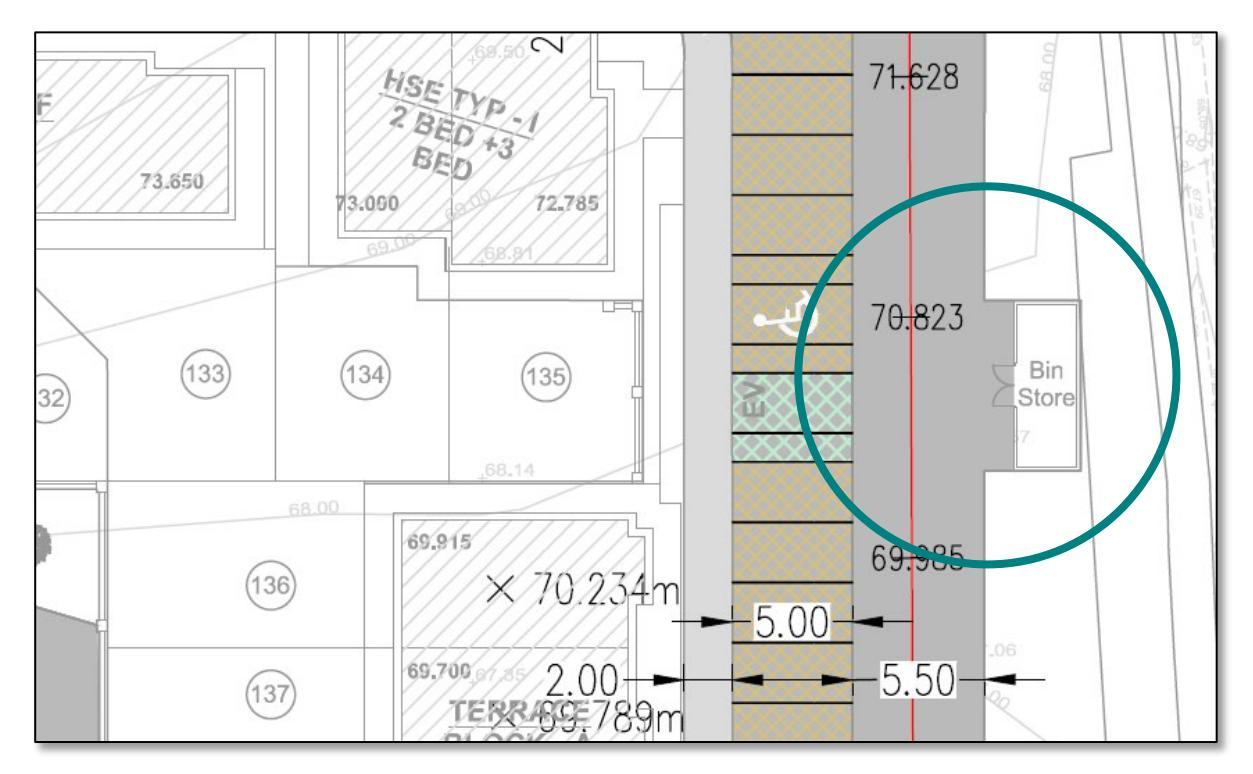
6.3 <u>Issue</u>

There is no pedestrian crossing or footpath provided to the bin storage facility provided at the south side of the development.

Adequate facilities are provided for pedestrians to access the bin storage facility. Refer to drawing **D111-CSC-XX-XX-DR-C-0025** for further details.

Ensure adequate facilities are provided for pedestrians to access the bin storage facility.

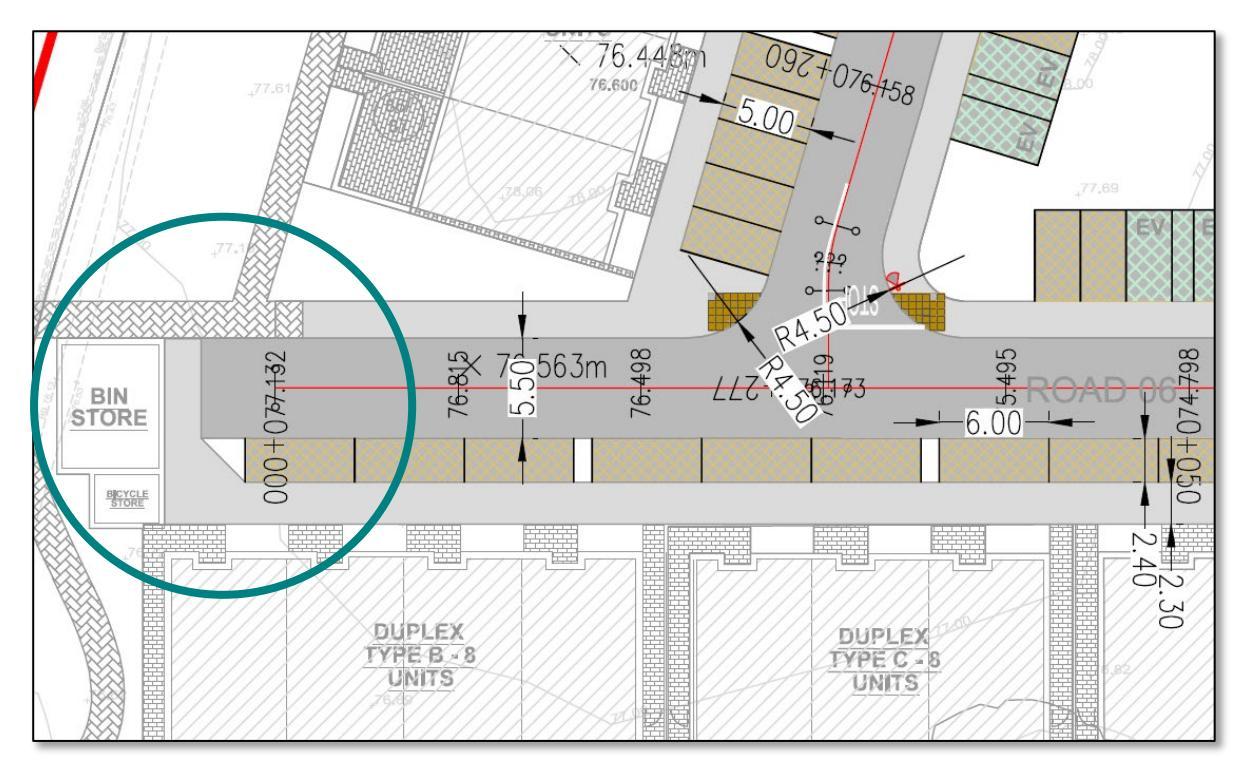
7.1 <u>Issue</u>

Bicycle parking is provided within the proposed development; however, cyclists may have difficulty accessing the bicycle parking spaces if they are required to cross a high kerb to access the bicycle parking area.

Dropped kerb shall be provided to ensure ease of access to bicycle parking. Refer to drawing **D111-CSC-XX-XX-DR-C-0025** for further details.

Provide dropped kerbs at appropriate locations to ensure ease of access bicycle parking.

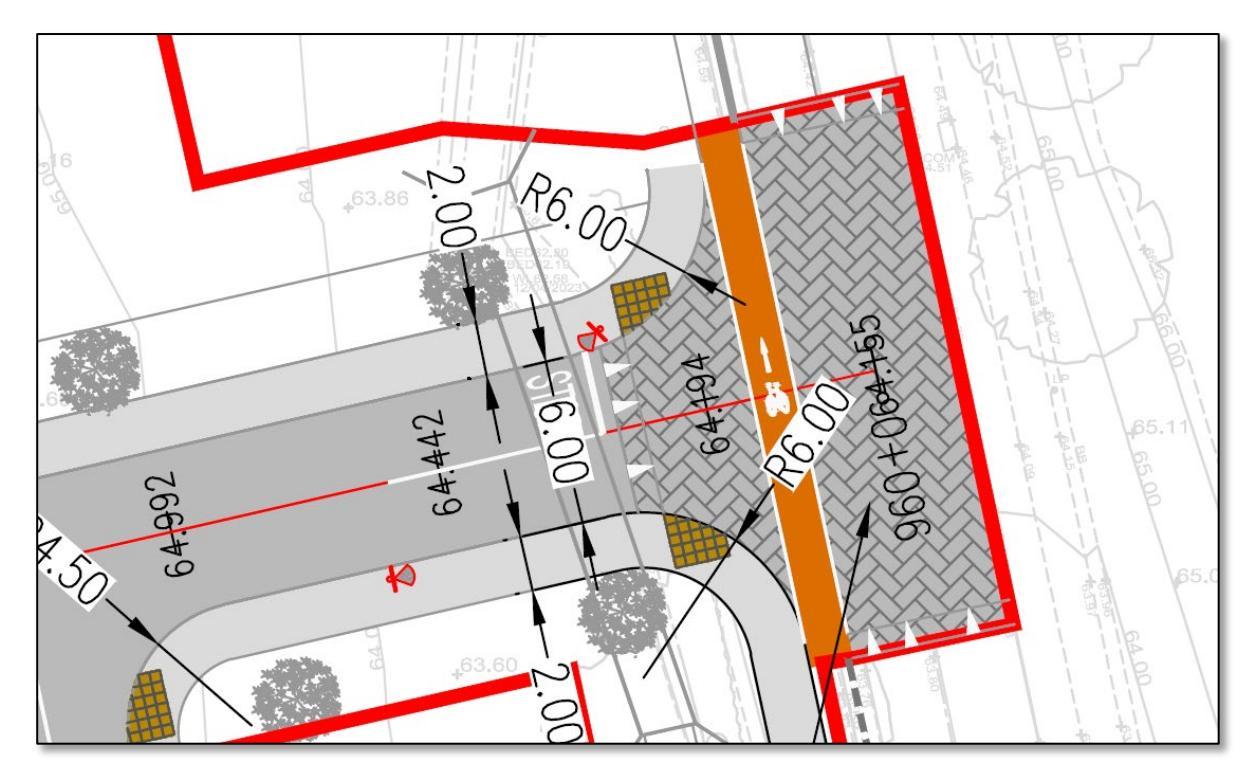
7.2 <u>Issue</u>

A raised table is proposed at the development access. Abrupt ramps reduce the attractiveness of cycleways and can be hazardous if very steep.

A raised table is proposed at the development access. Abrupt ramps reduce the attractiveness of cycleways and can be hazardous if too steep.

The slope of the cycle ramp shall be less than 5% to cater for easy and safe movement for cyclists. Please refer to CS Consulting drawing no. **D111-CSC-XX-XX-DR-C-0025** for details.

Ensure that the slopes of ramps are adequate to provide for the easy and safe movement of cyclists.

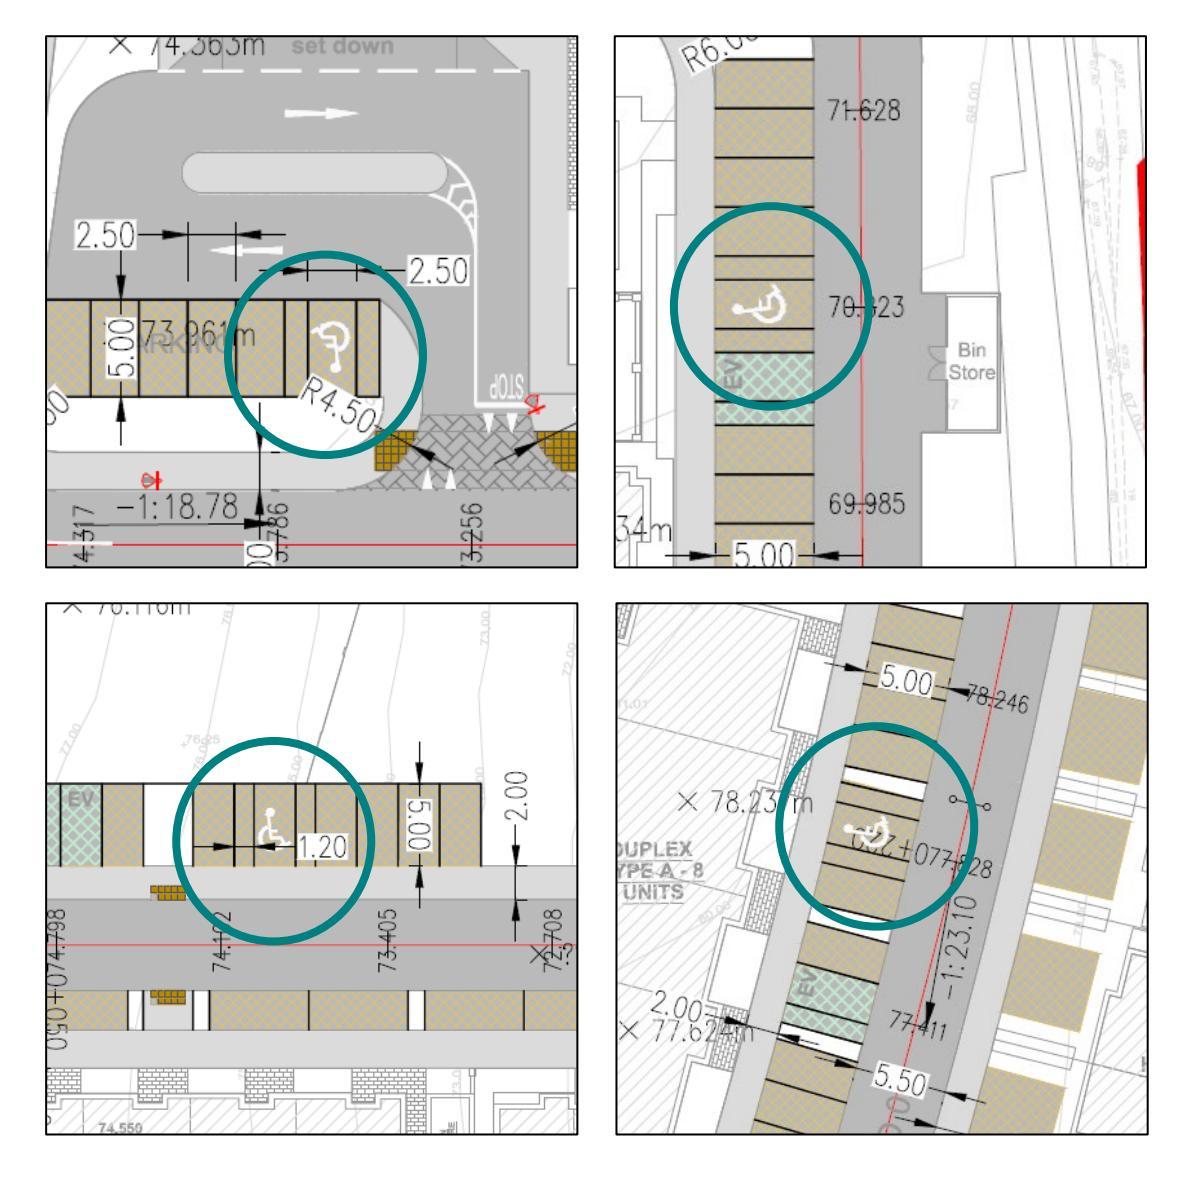
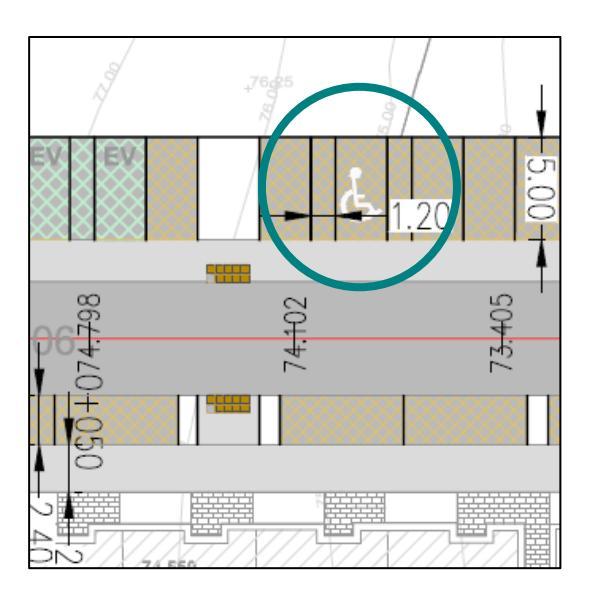
8.1 <u>Issue</u>

Accessible parking spaces are provided within the residential development; however, dropped kerbs or tactile paving are not shown to be provided to enable a mobility impaired pedestrian to access with ease the footpath adjacent to the accessible parking space.

Dropped kerbs and tactile paving shall be provided to enable mobility impaired pedestrians to directly access the adjacent footpath. Please refer to CS Consulting drawing no. **D111-CSC-XX-XX-DR-C-0025** for details.

Provide dropped kerbs and tactile paving to enable mobility impaired pedestrians to directly access the adjacent footpath.

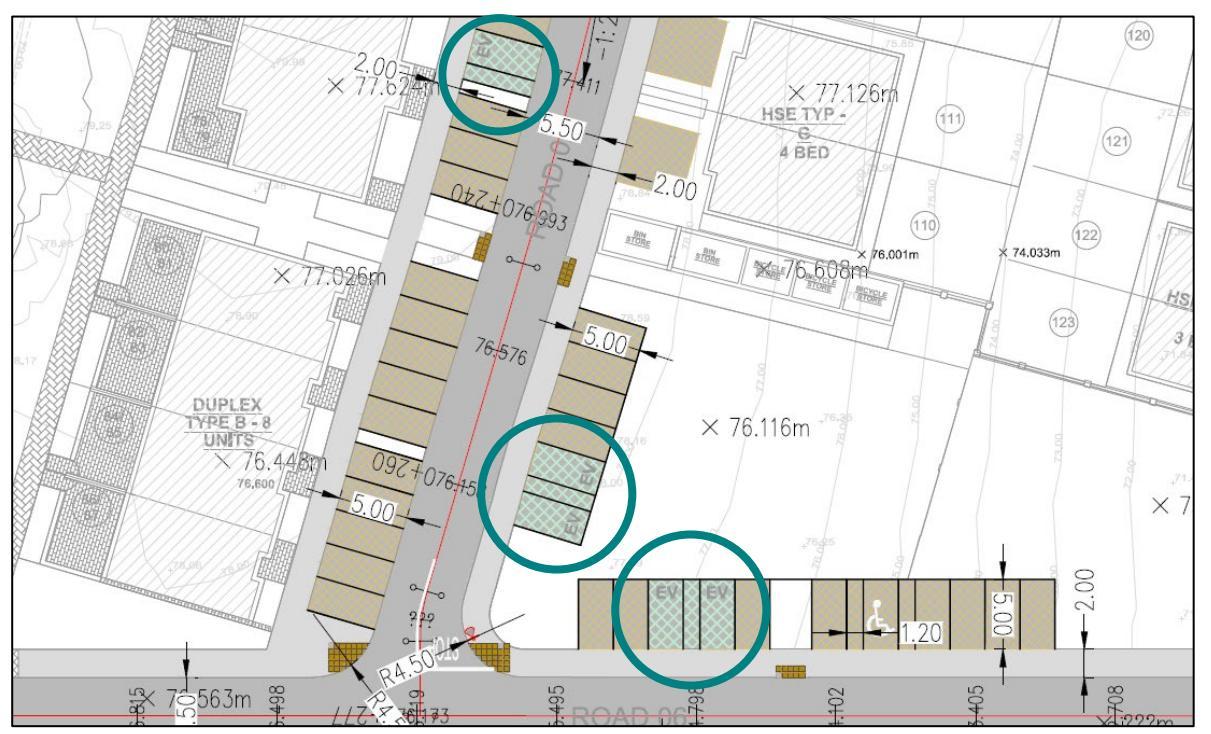
8. 2 <u>Issue</u>

At EV charging spaces, the locations of the charging equipment are not shown. If cables trail across footways they could be a hazard to mobility impaired pedestrians.

All the EV Chargers shall be located such that the cable will not trail across footways and the charging equipment does not obstruct footway widths. Please refer to CS Consulting drawing no. **D111-CSC-XX-XX-DR-C-0025** for details.

At all locations where EV chargers are to be provided, ensure that cable will not trail across footways and that the charging equipment does not obstruct footway width.

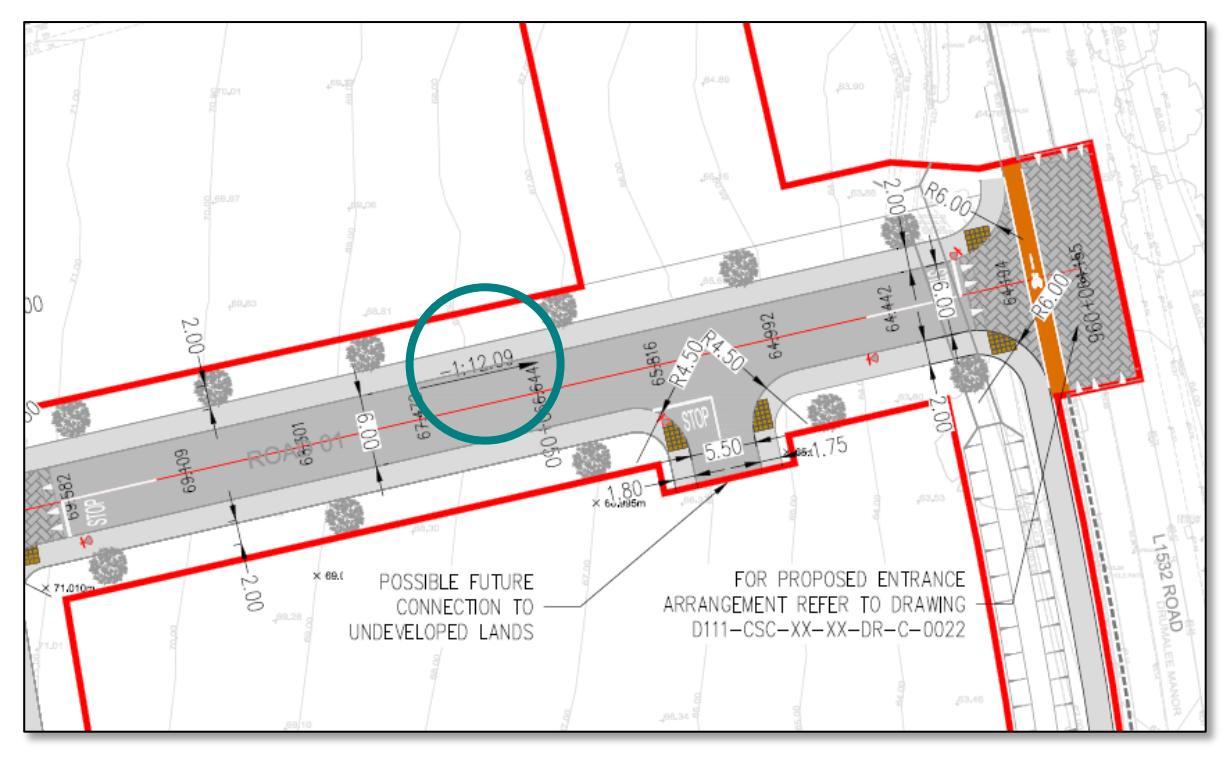
8.3 <u>Issue</u>

The footways along the access road to the development have a longitudinal gradient of 1 in 12, steeper than is adequate for universal access. An alternative pedestrian route is shown to be provided for pedestrian and cyclists; however, the gradients of the shared path are not indicated on the drawing. If they are too steep universal access may be restricted.

The gradient of the proposed shared surface shall be 5%, and this shared surface is designed in accordance with Cycle Design Manual 2023. Please refer to CS Consulting Drawing no. **D111-CSC-XX-XX-DR-C-0025** for further details.

Ensure that the slopes of the shared path are not so steep as to constrain universal access, and that adequate dwell areas are provided.
